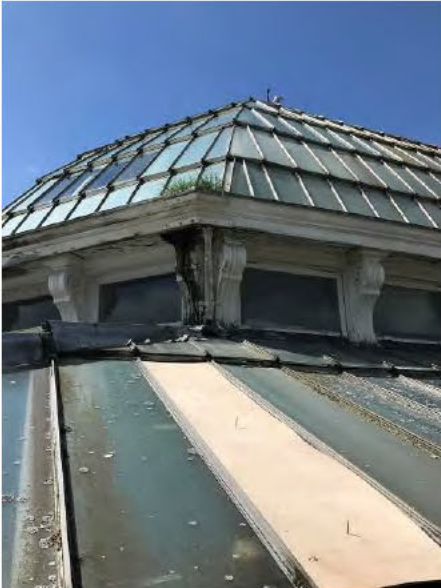
Photo 1 – Rotting timber scrollwork to Temperate cupola roof.

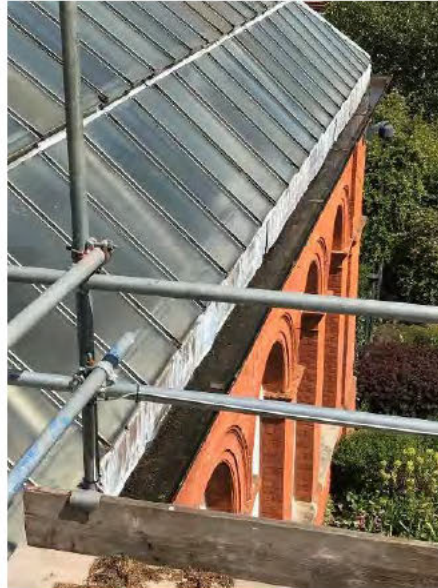
Photo 2 – Lead flashing to roof looks tired and guttering requires cleaning.

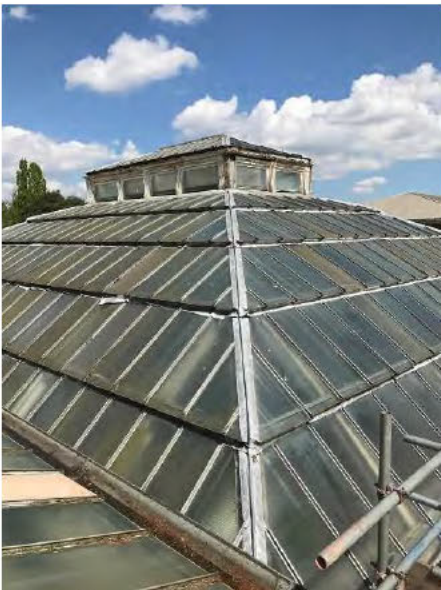
Photo 3 – The Bird Room: Lead flashing on roof structure is loose and hanging off in areas. Rotting timber to cupola roof.

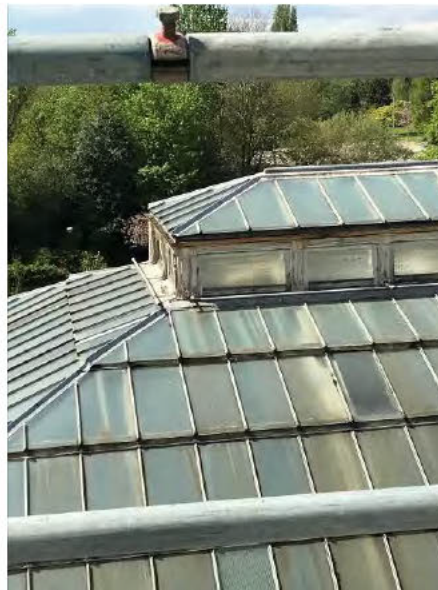
Photo 4 – The Tropical Room: Rotting timber to roof cupola. Damaged glazed panels throughout roofing structure.

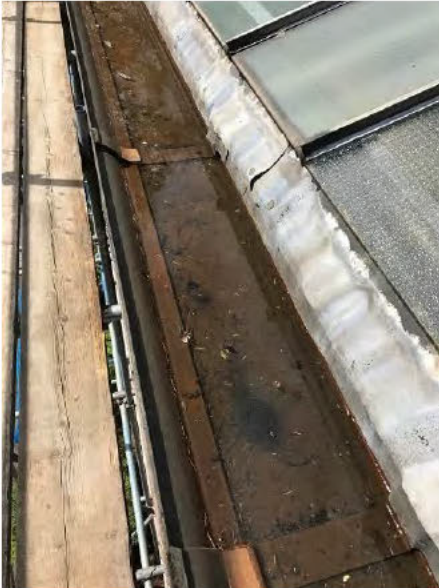
Photo 5 – Roof structure valley gully showing signs of corrosion and in need of cleaning.

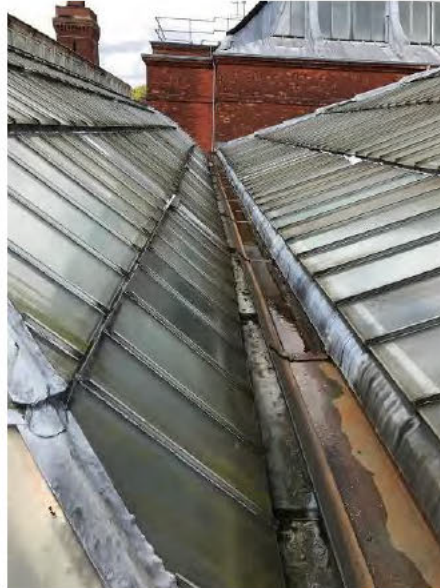
Photo 6 - Roof structure valley gully showing signs of corrosion and in need of cleaning.

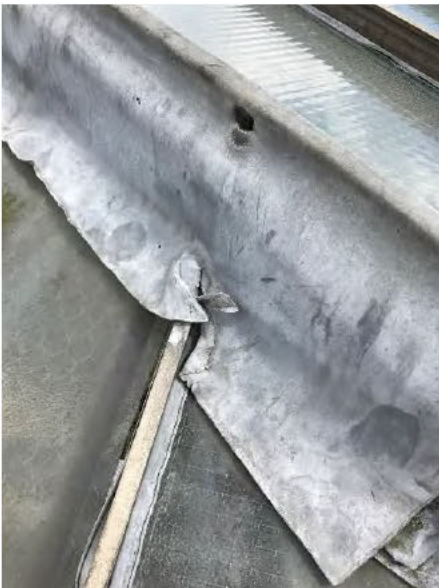
Photo 7 – Fissure to lead capping above glazing bar.

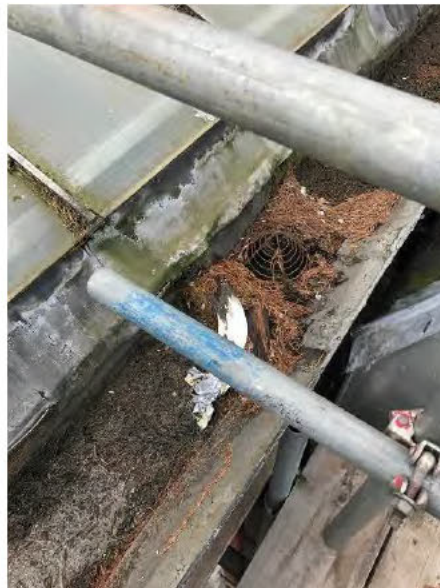
Photo 8 – Roof structure cast iron guttering outlet full of debris.

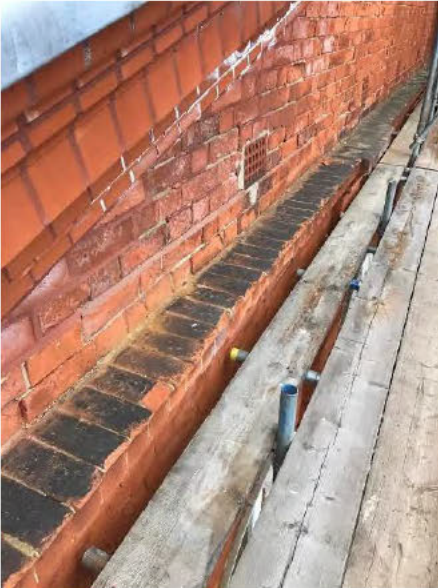
Photo 9 – Efflorescence staining and minor spalled brickwork to high level external wall.

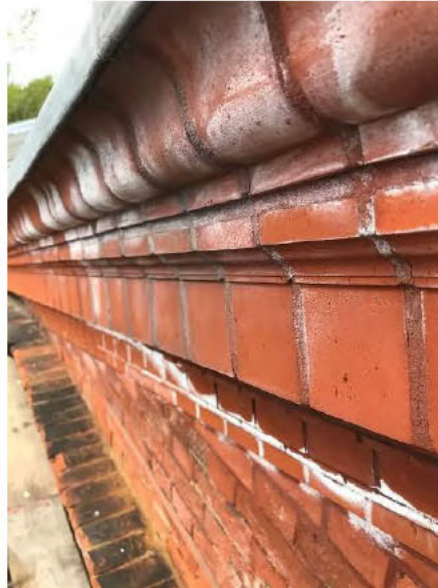
Photo 10 – Efflorescence to high level external brickwork cornice.

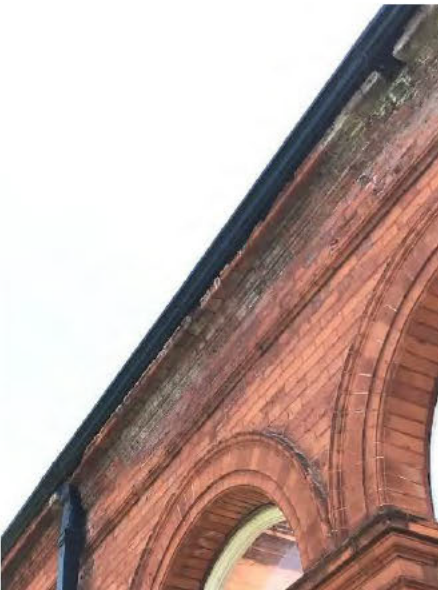
Photo 11 – Algae growth to external walls at high level and underside of cast iron guttering.

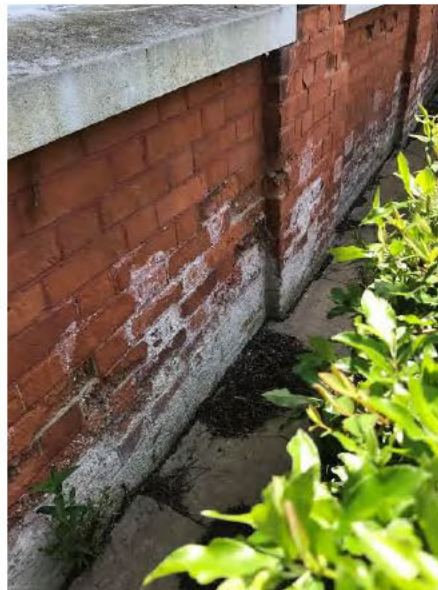
Photo 12 – Minor spalling and efflorescence staining to external brickwork at low level.
